## **SITE INSPECTION (SI) SAMPLE PLAN**

Site Name: **Athens Furniture, Inc.**  
Location: **Athens, McMinn County, Tennessee**  
EPA ID #: **NA**  
TDoR File #: **54-519**

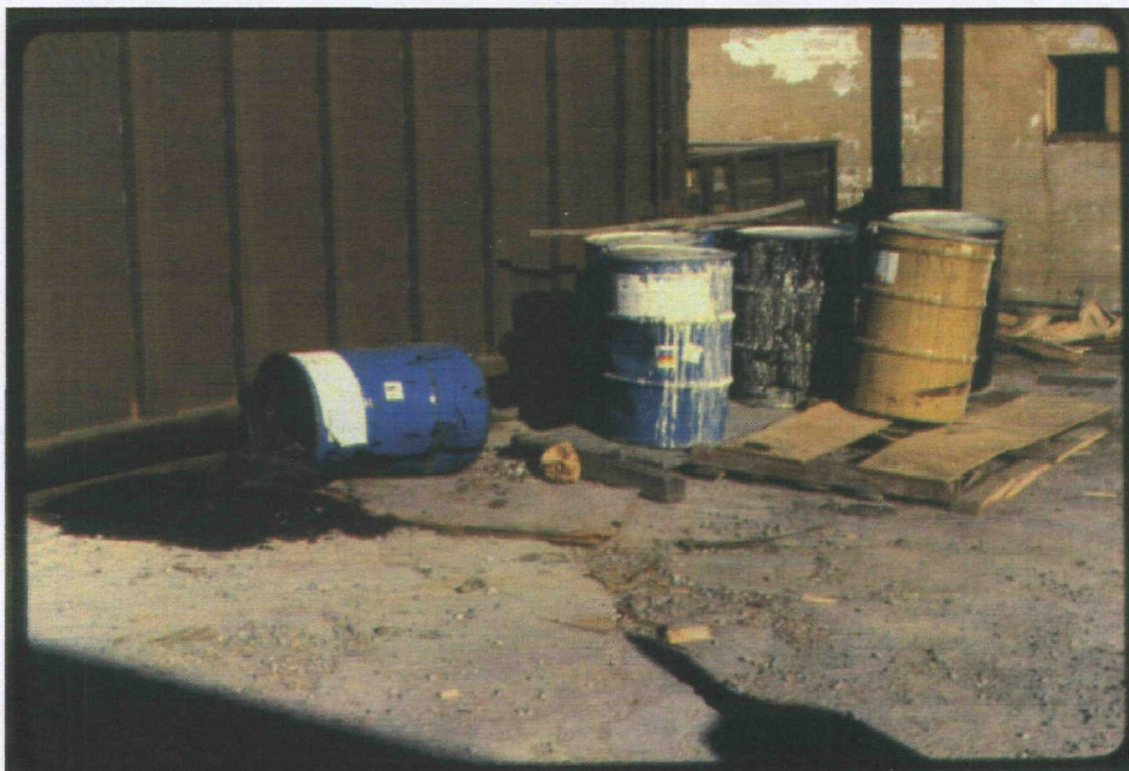
**Photo 1:** Drum Storage Area.

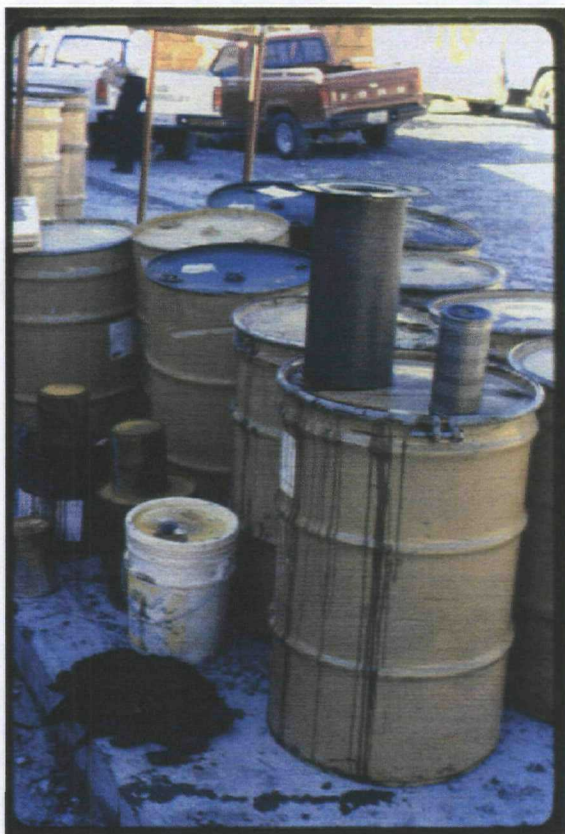
**Photo 2:** Drum Storage Area.

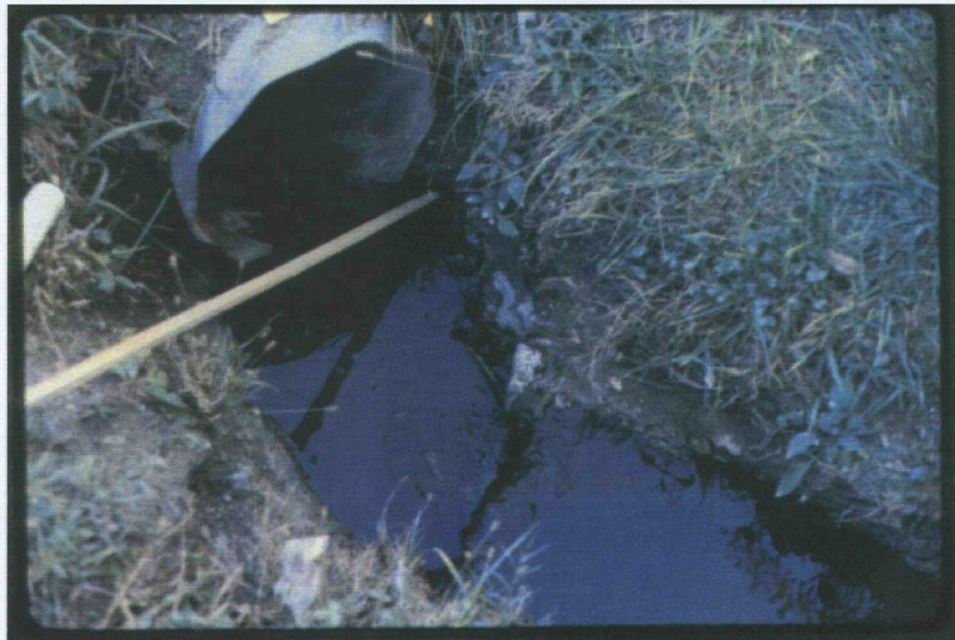
**Photo 4:** Same as above, storm drain near Athens Furniture and Matlock Road.

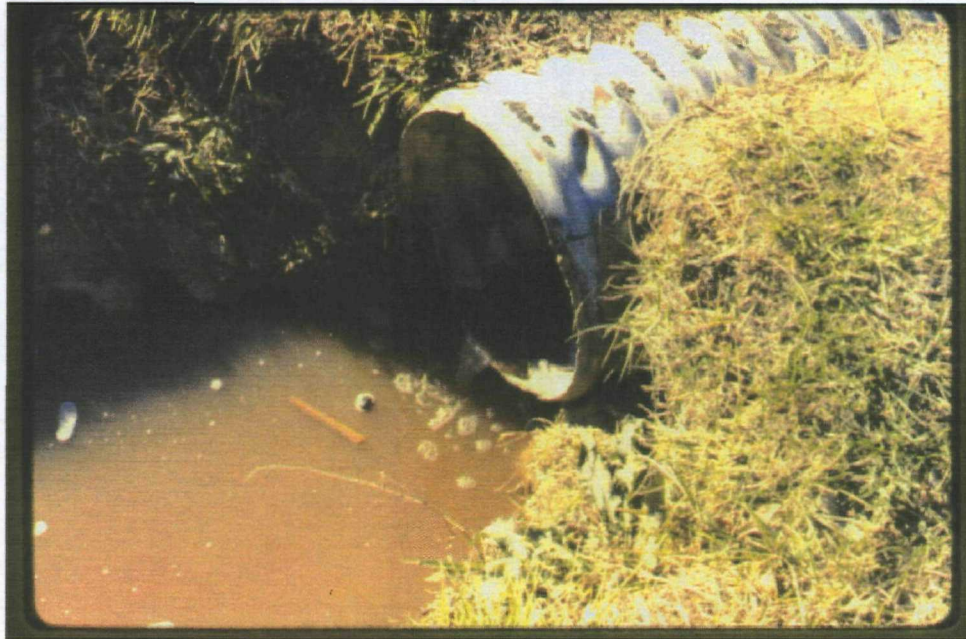
Photo 5: Same as above.

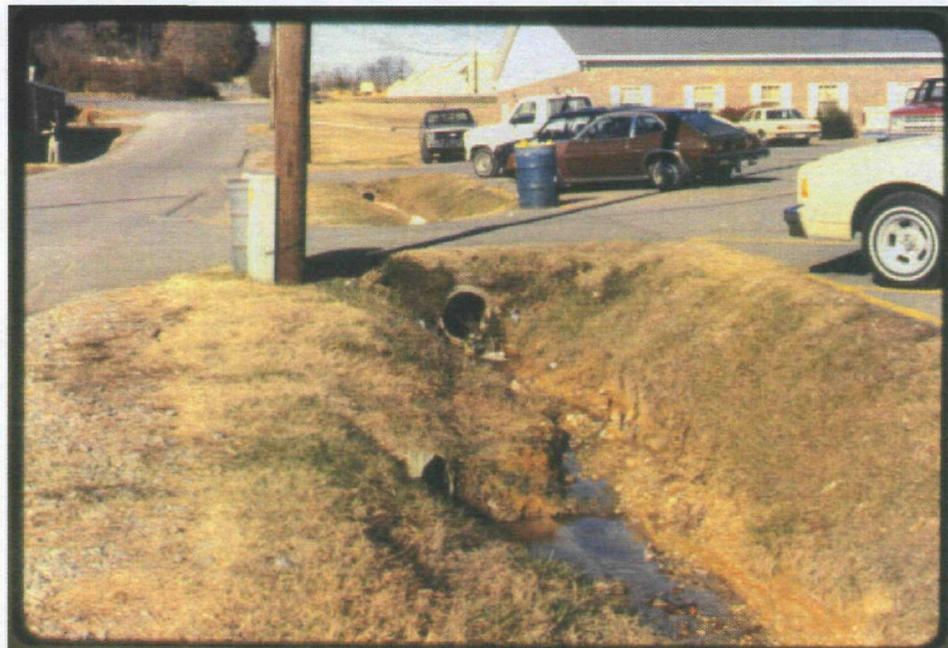
Photo 5: Same as above.

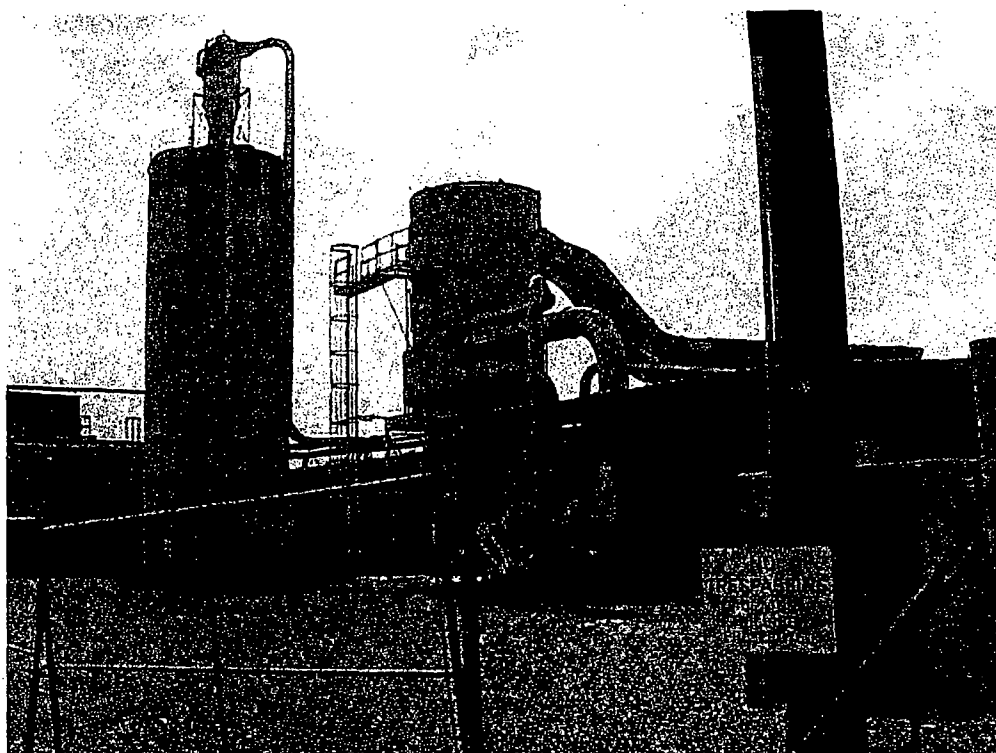
**Photo 1:** View of vacant, former Athens Furniture facility as seen from main gate off of access road from Old Riceville Rd. Photo taken facing east.

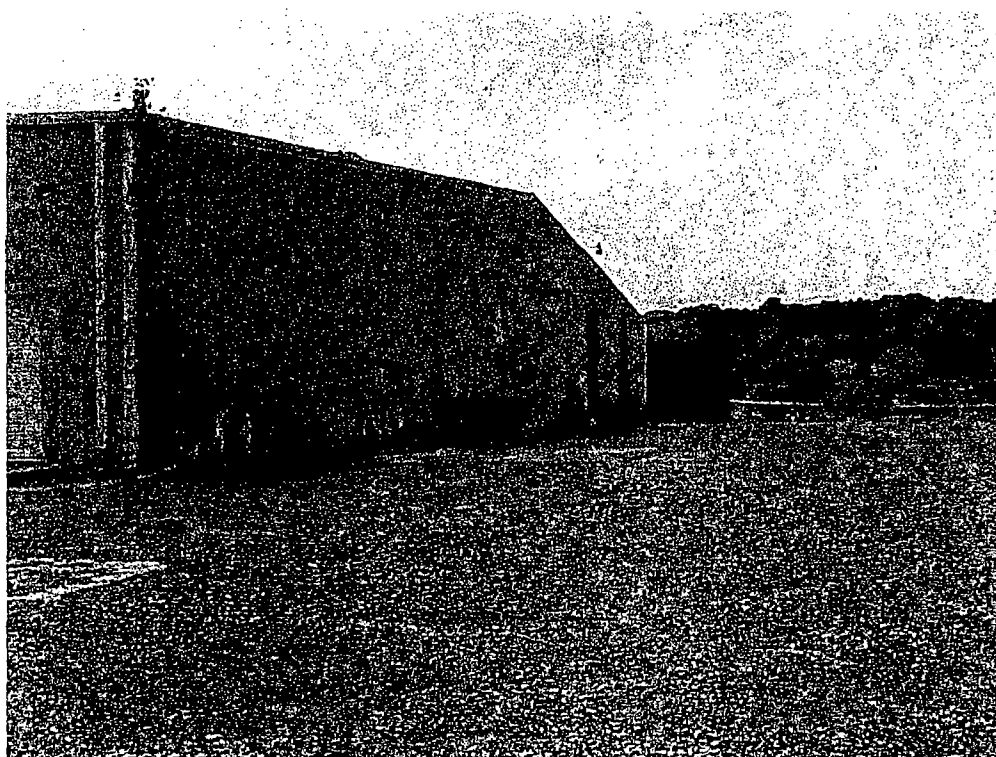
**Photo 2:** View of the fire damage in western facility building. Photo taken facing SW.

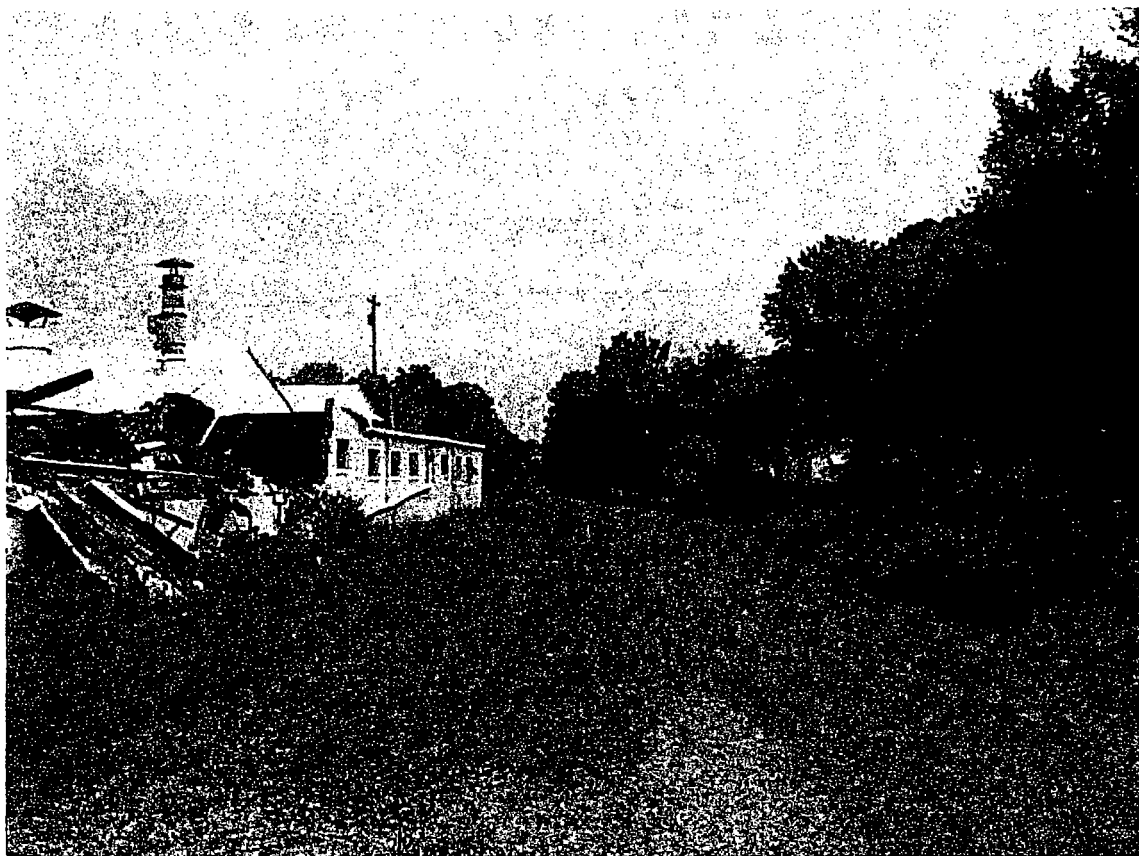
Photo 5: View of access road on ~~Southern~~ property boundary. Note abandoned facility structure on left and residence on right. A rail line borders the access road on the right. Photo taken facing East. <sup>Part 303</sup>

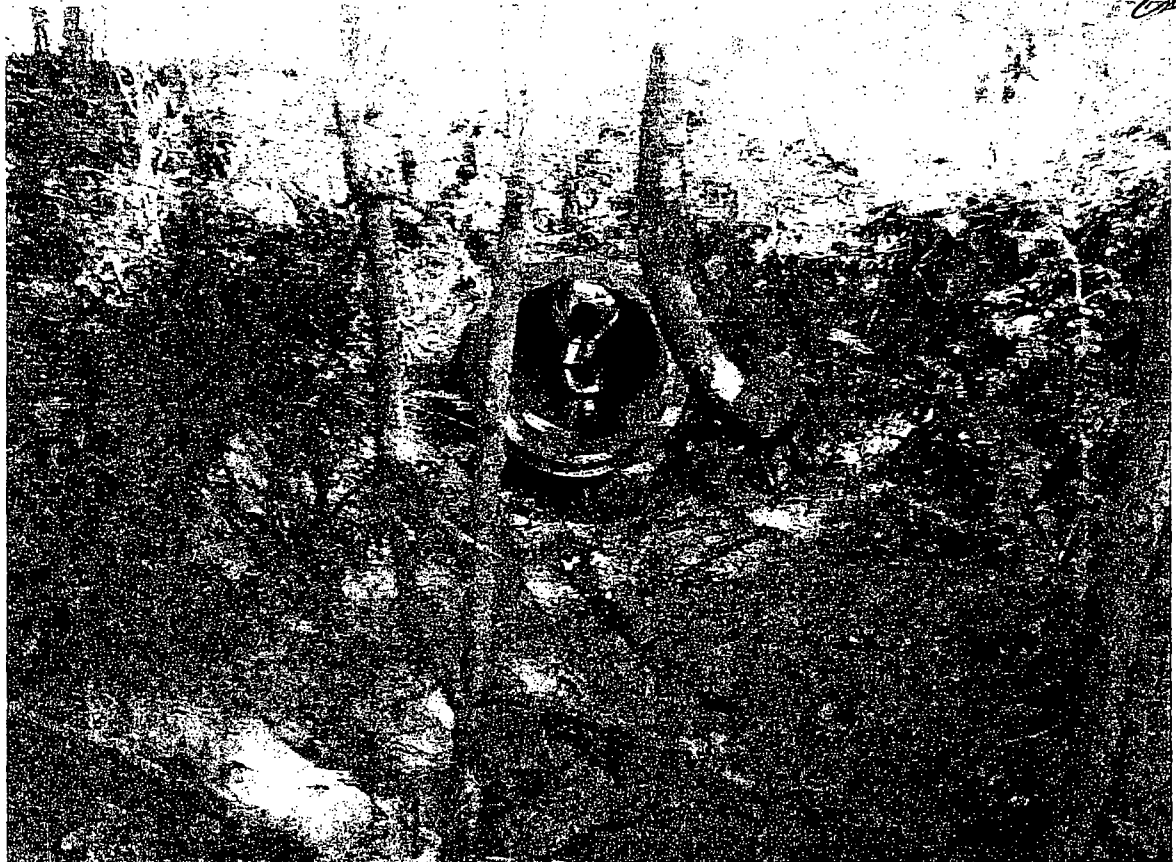
Photo 1: Photo shows approx. 18inch Concrete pipe located on southern side of site which is discharging into a ditch on r/r easement. Note the Approx. 6inch PVC pipe inside the concrete pipe.

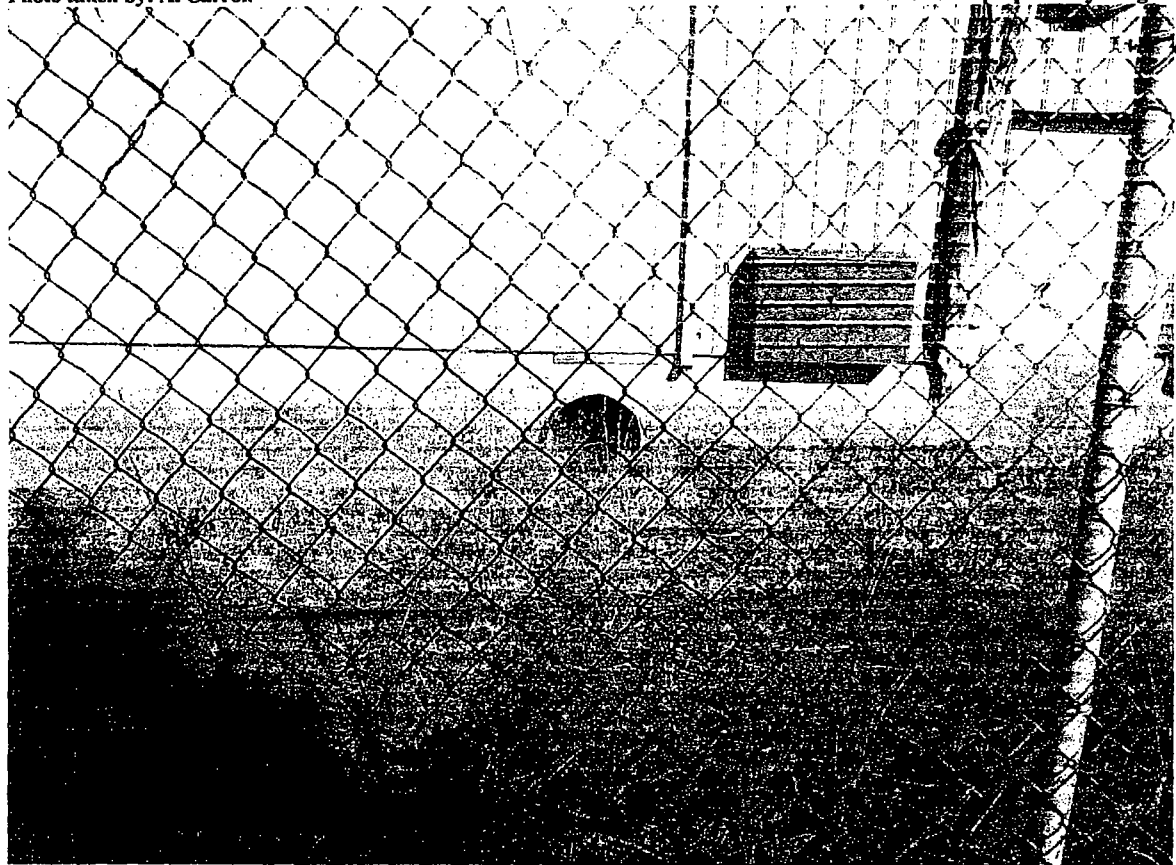
Photo 2: Corrugated metal pipe located on south side of building near cemetery. Photo taken along fence line of Athens furniture and Cemetery. Photo taken facing north.

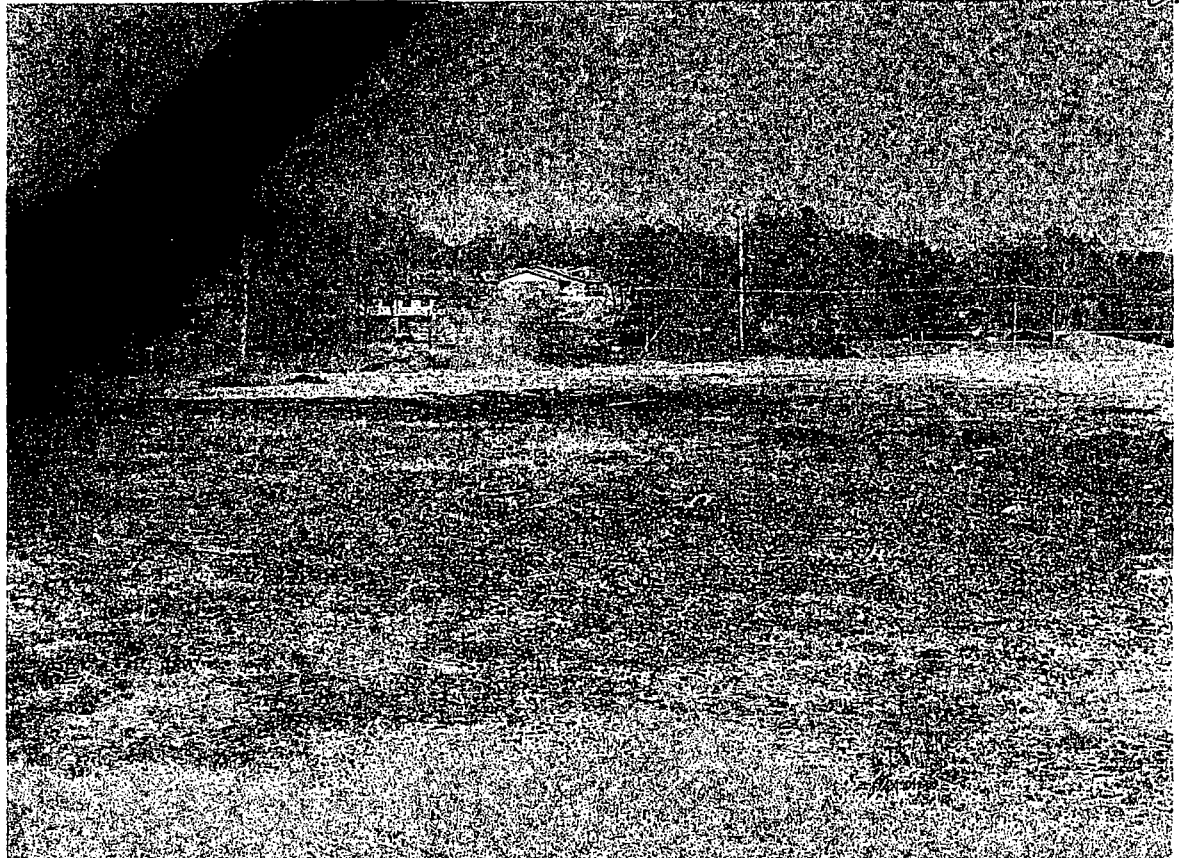
Photo4: Additional Photo taken of darkened soil found on the southeast corner of site near cemetery and Old Riceville

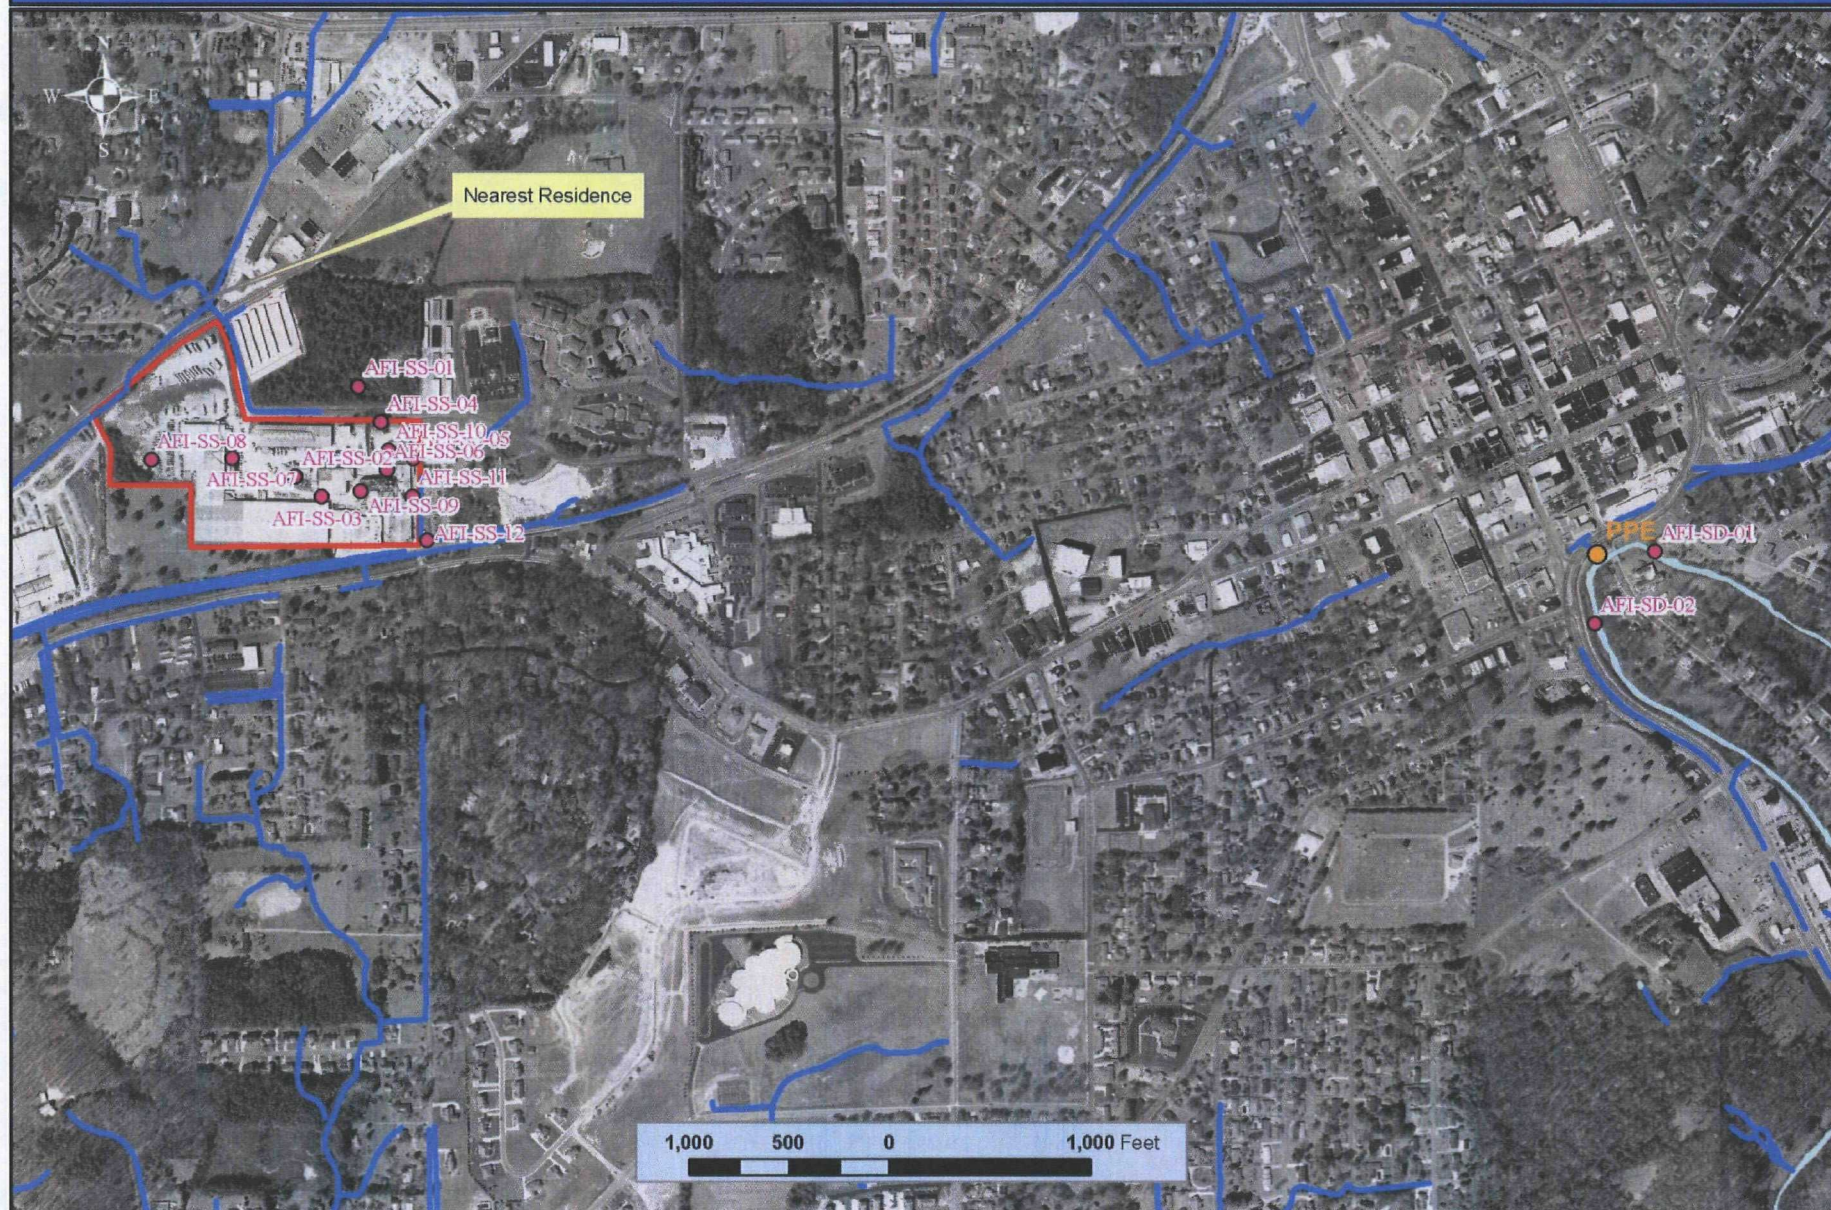
Figure 3a

- Site Boundary
- Drainage and Surface Water
- Proposed Sample Location

Athens Furniture  
Sample Location Map  
EPA ID: TND000814525  
TDoR Site ID: 54-519

Two sediment samples will be collected from three locations, plus one duplicate sample, and one MS/MSD sample (Table 1; Figure 3). Sample locations may be adjusted in the field based on conditions encountered or if new information becomes available.
